AALTO UNIVERSITY  
School of Engineering  
Department of Civil and Structural Engineering  
Building Materials and Building Technology

## **Fire barrier penetrations – Interactions between concrete and sealing materials**

Master's thesis which has been submitted for Master of Science degree.  
At Espoo, 28.04.2014

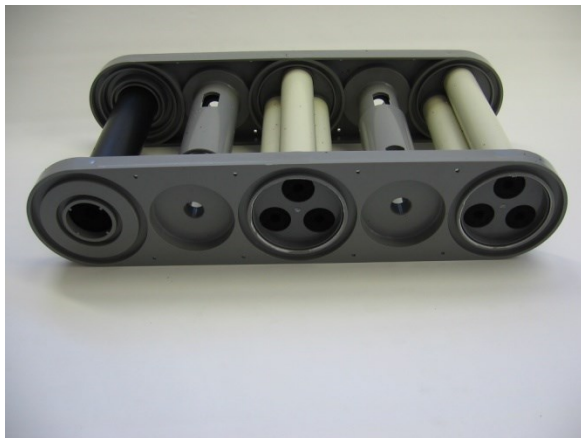
Picture 8 Modular firestop system for cable penetrations (Sewatek Oy, 2014)

There are also products that can be installed at the site during or after the casting of concrete. These products have specific needs for the penetration diameter. Done either way, this shortens the time needed in the construction site to seal the penetrations. There are no need to schedule many different workers to work at the same place, because modular firestop systems ensure easy feed through of cables and pipes without need of firestop sealants. It is also possible to have reservations for future additions. Picture 8 shows product, which can be installed during casting in-situ, or in concrete element factory. (Sewatek Oy, 2014; Rextec International AB, 2014.)

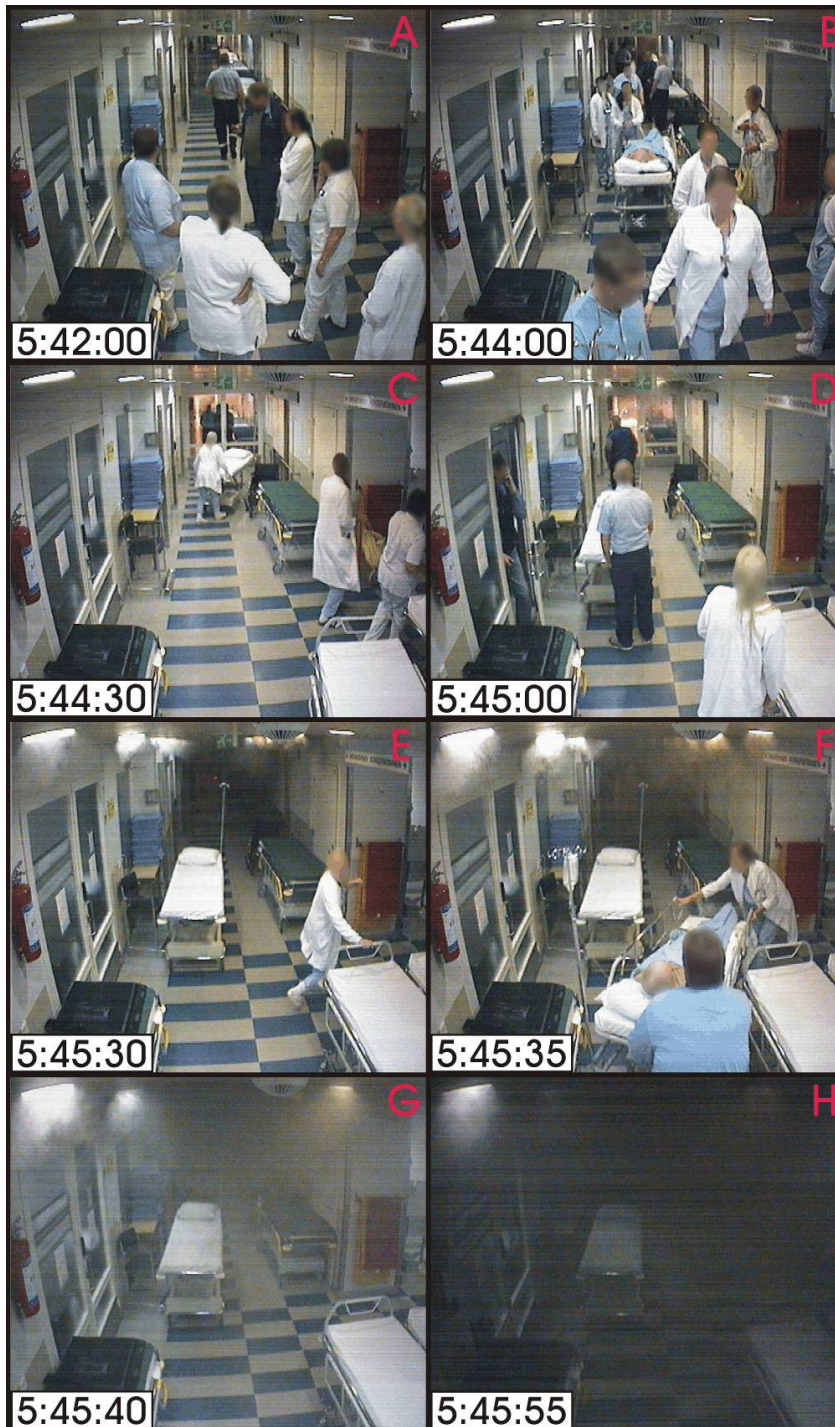
Picture 10 Pictures taken from surveillance camera video on 2nd floor (Onnettomuustutkintakeskus 2012. p.13)

In this case the fire started in the suspended ceiling, on the 2<sup>nd</sup> floor of A-hospital (Picture 11). Probable cause for fire was electrical malfunction in the nurse-calling system, whose main unit was located inside suspended ceiling. Therefore the fire couldn't be detected directly from the flames. First detection of fire was because of smoke started to develop and come through the ceiling in the corridor, where it was first noticed by nurses. However the precise spot of fire was not detectable. In the upper floors there were fire alarms from the alarm system, but these were first neglected due to large number of false alarms during summer. Fast spreading of smoke and fire can be seen from surveillance footage in Picture 10. Time span between the first sighting of the fire in screen C and corridor filling up with smoke in screen H is under two minutes.

Combustion gases were the most dangerous element in this case. Because suspended sealing didn't have effective firestops, the gases flew inside the sealing virtually everywhere in the floor and even to upper floors. The ventilation was also one way for the gases to travel as the ventilation pipes weren't perfectly sealed at every joint. There was also confusion about shutting down the ventilation system among the staff (Onnettomuustutkintakeskus, 2012. p. 61). Situation wouldn't have been so severe if the fire had started in some of the upper floors. The floors below the fire wouldn't have been in immediate danger. Second floor was maybe the worst possible floor in this case because that led to a danger in every upper floor also. The fast spreading of smoke and gases can be clearly seen below in Picture 10.

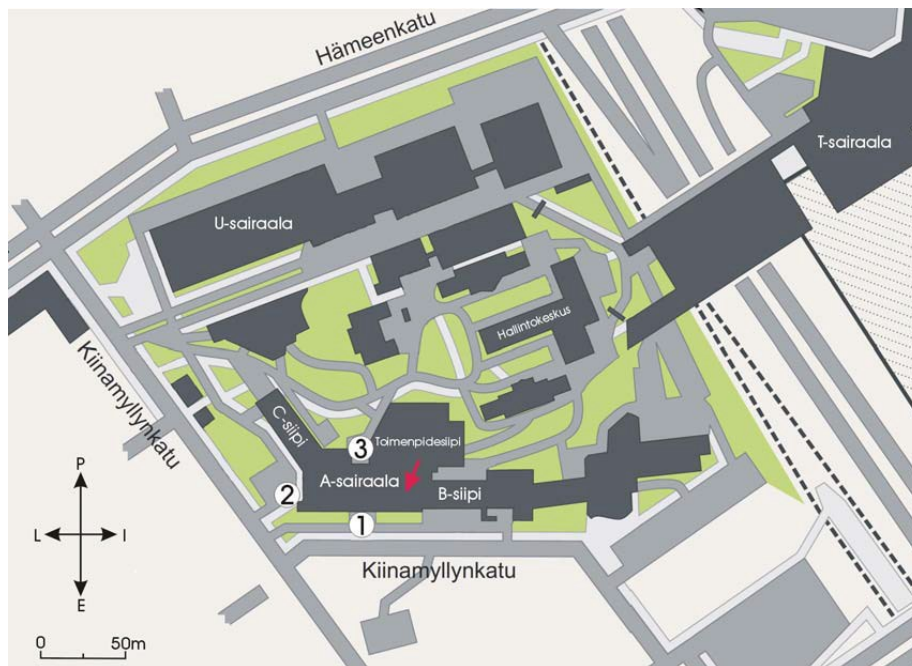
Picture 11 TYKS Area, arrow indicates the fire starting point (Onnettomuustutkintakeskus, 2012. p.11)

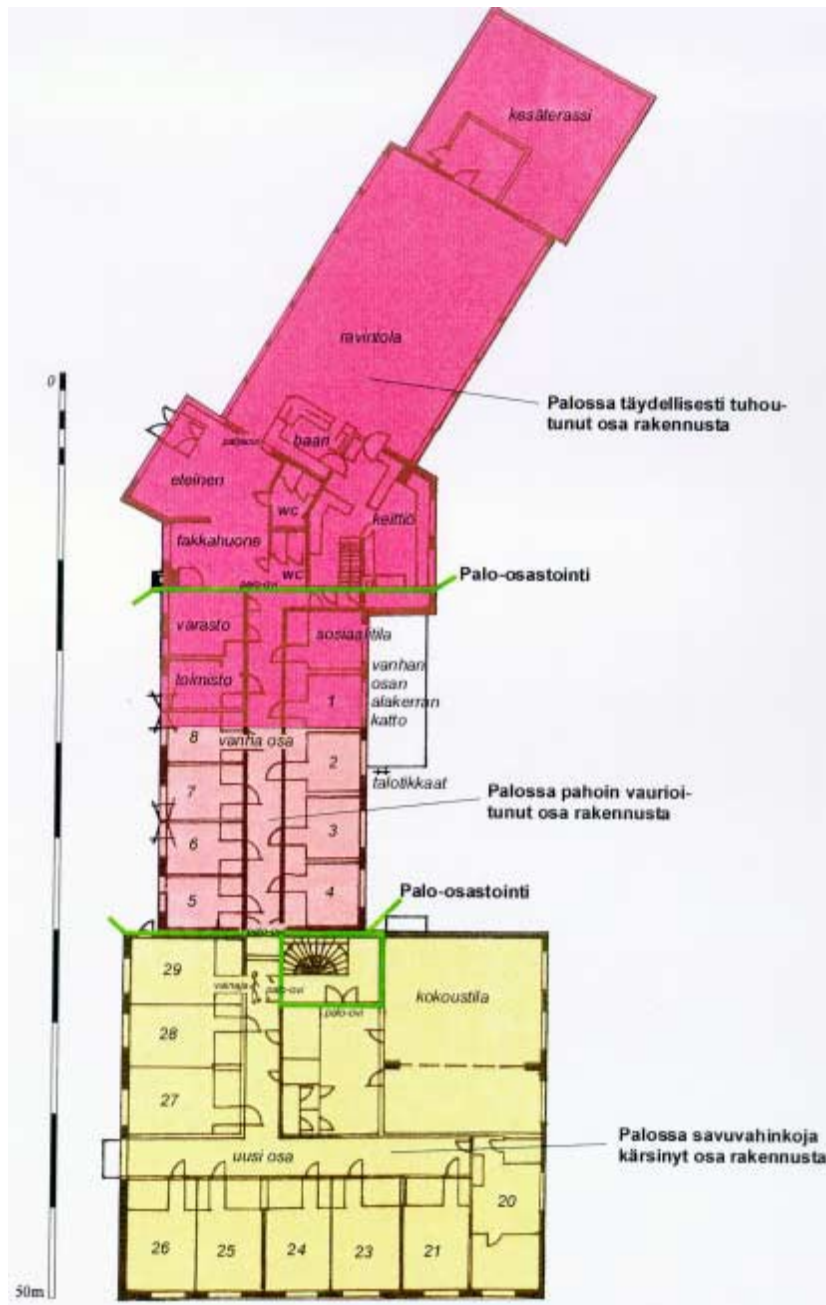
Picture 12 Fire compartmentation of the upper floor in hotel

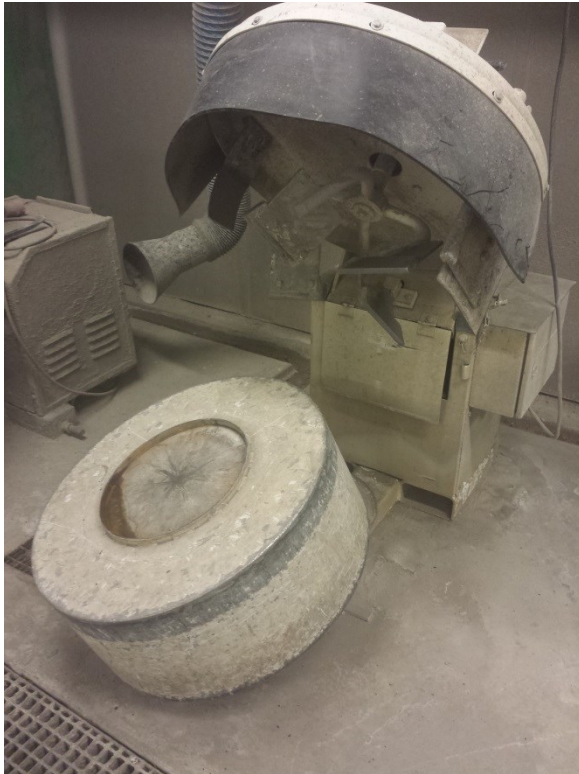
Picture 13 Concrete mixer

**Concrete mixing machine:** Pan type concrete mixer.

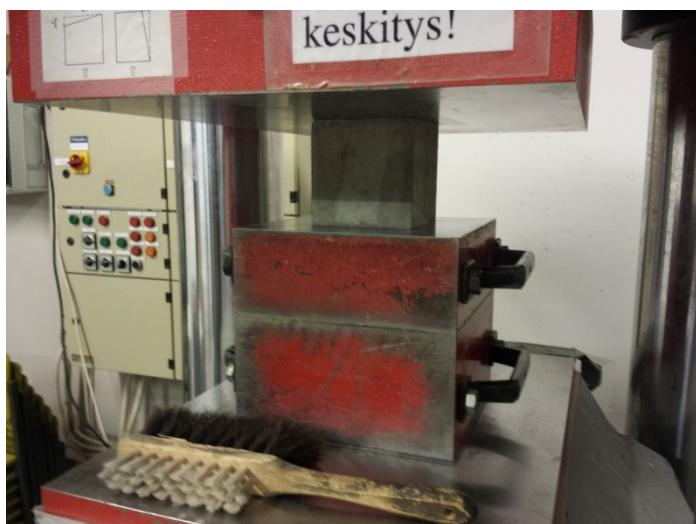
Picture 14 Compression strength testing machine and test sample ready to be tested

**Compression strength test machine:** Toni Technik, Processor B. Ranges 50 – 2000 kN.

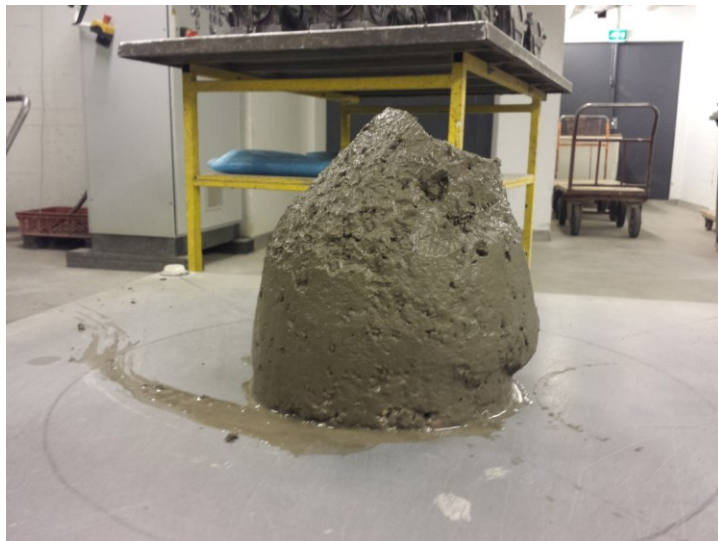
Picture 15 Fresh OPC mix after slump test

After mixing, fresh concrete was measured for air content (SFS-EN 12350-7), density and workability (SFS-EN 12350-2) (Picture 15). Test results proved that requirements were met. Results from tests can be found below in Table 3.

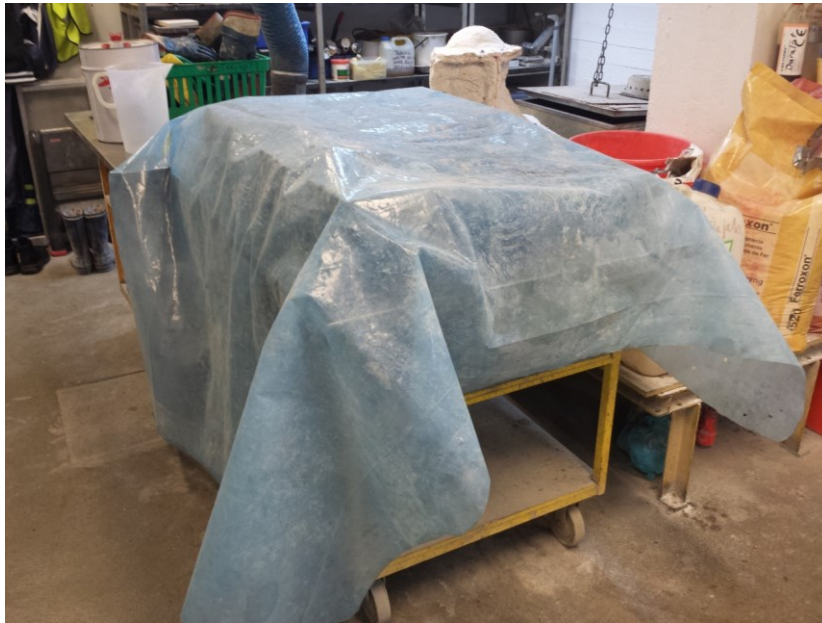
Picture 18 Test samples under plastic sheet after casting

Curing of concrete cubes was done as follows. First after casting molds were covered with plastic sheet (Picture 18) for 24 hours after which samples were demolded. Then both sets of samples were cured in 95% of relative humidity (Picture 19). OPC samples were cured for 7 days, and HPC samples for 5 days, because it wasn't possible to move the samples during weekend. Concrete samples were then transferred to a steady state weather room, in which

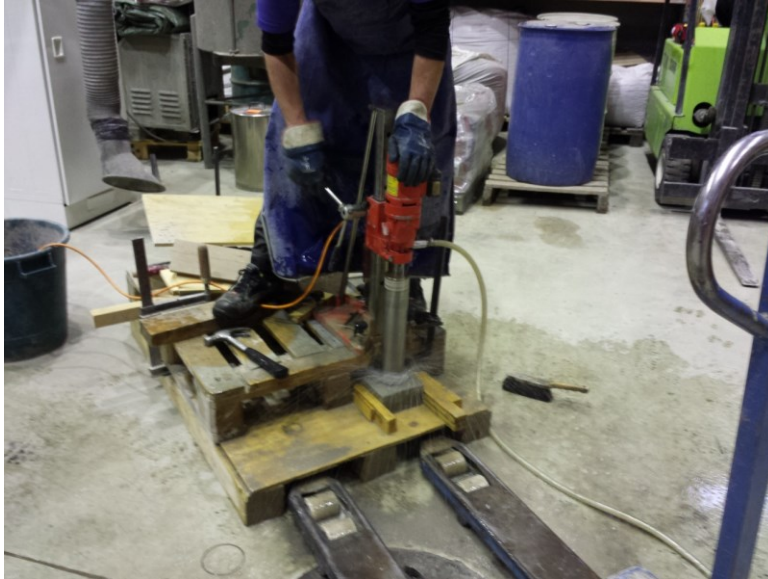
Picture 23 Drilling the holes to concrete

Holes with diameter of 75 mm were drilled to test samples after cutting each cube into two halves (Picture 23 and Picture 23). Due to excessive amount of water used in cutting and drilling we decided to let the samples to dry out for additional 7 days before finishing the manufacturing process with plastic pipes and firestop sealing. With this long drying period we wanted to prevent the effects of moisture in concrete to adhesion of firestop mastics. Although technical data sheets of products suggested that applying of mastic is possible when the surface of concrete is dry, we wanted to be on the safe side.

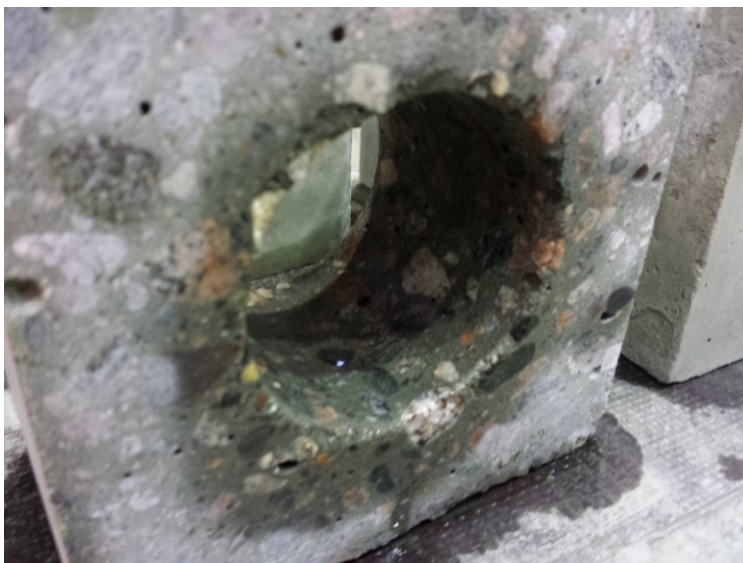
Picture 24 Cut and drilled concrete sample

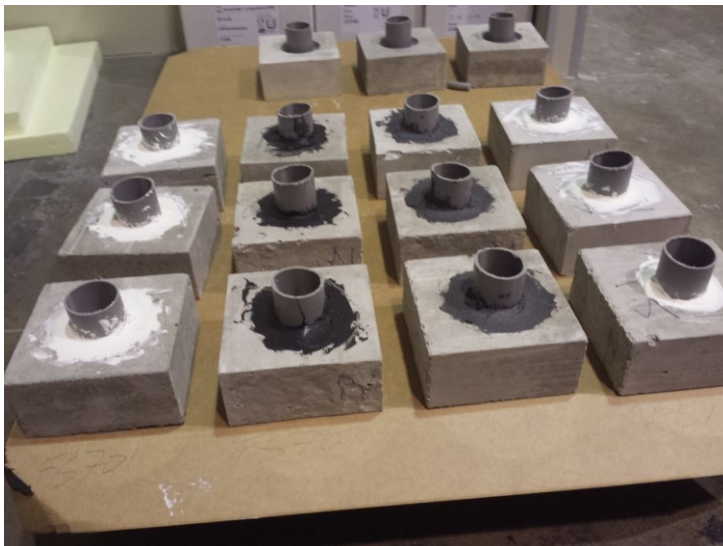
Picture 26 OPC samples with pipes and sealants, from left: acrylic, silicone, graphite and hybrid (non-fireproofed)

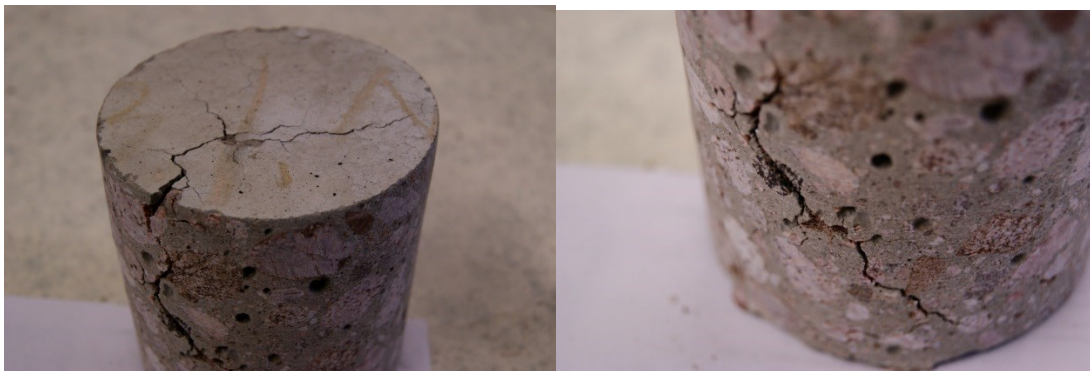
Picture 30 OPC 45 % at 800°C

Concrete in maximum of 800°C was cracked and showed clear signs of aggregates deterioration as well as concretes. Also some spalling happened to the OPC pieces. HPC pieces again were

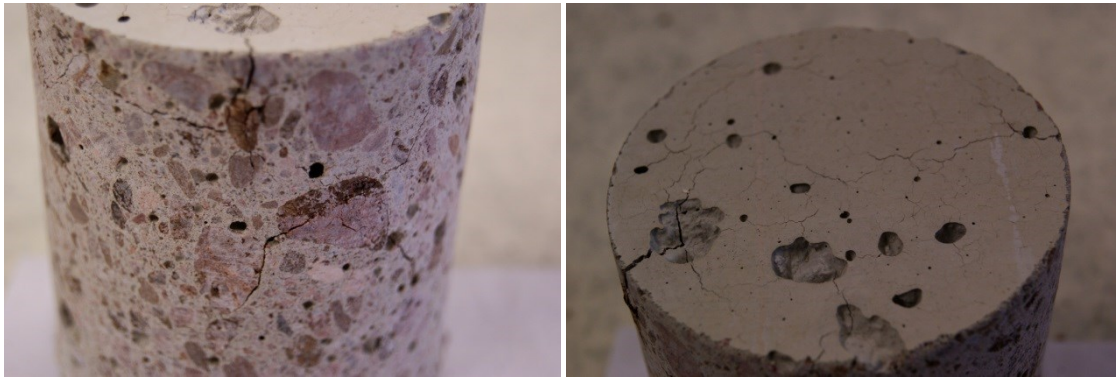
Picture 32 HPC 45 % at 800°C

less damaged and smaller cracks were visible. Probably the reason behind this is the smaller water-cement ratio of HPC samples, so there is less water to vapour from inside the concrete.

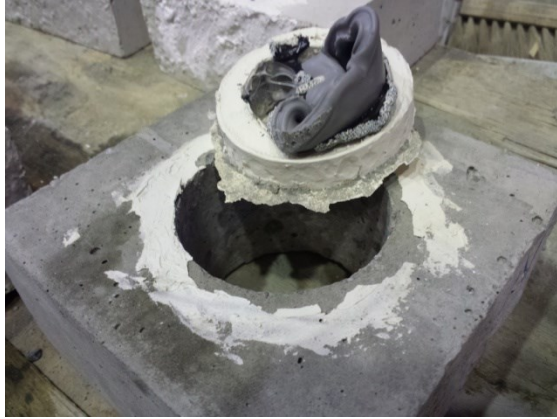
Picture 34 Removing remains of pipe and mastic.

First, the remaining mastic and pipe was removed (Picture 34). Second, samples were drilled of the concrete (Picture 35) and then cut in to pieces about 2,5 cm in diameter and 0,5 cm in thickness. Samples were taken from both OPC and HPC samples, which had silicone and intumescent sealants and gypsum mortar. This decision was based on differences in behavior between these combinations observed after heating test. Samples were then impregnated with epoxy resin and polished after hardening. Samples were analysed with SEM and pictures were taken.

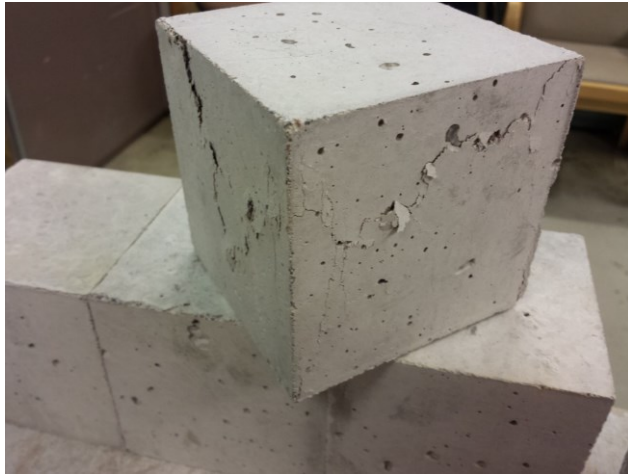
Picture 37 Crack formation on HPC test sample during compression strength test

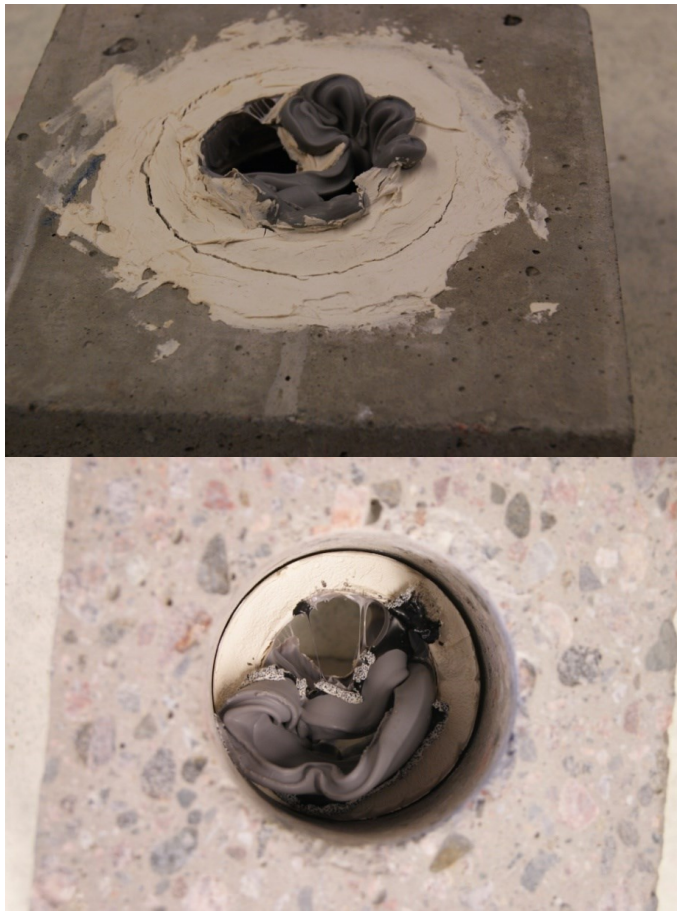
Acrylic mastic, FS701, lost some of its adhesion with the concrete on the upper side of penetration. Adhesion between pipe and mastic was also lost, and pipe was collapsed to the bottom of penetration. This means air tightness loss and possibility for exhaust gases to move through the penetration, which is definitely not desired outcome for this low temperature. Of course, acrylic mastics aren't supposed to be used with penetrations consisting lots of movement or deformations, so this observation is not so important in this case. However acrylic mastic should expand little and increase its volume. Based on the obtained result it's hard to tell if there has been any expanding or not.

Picture 39 FS701 OPC sample after test at 200°C

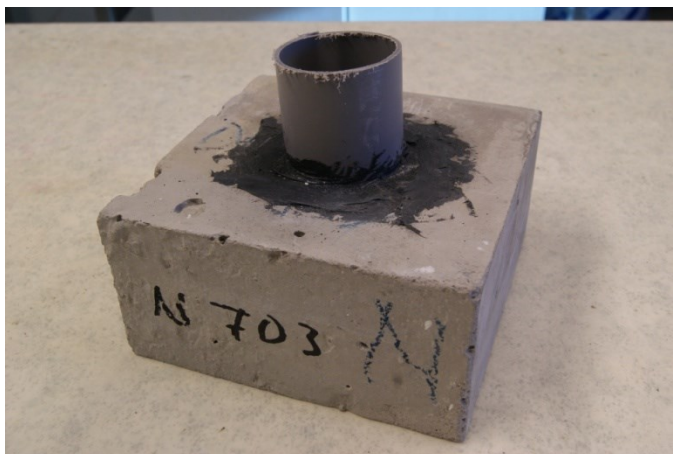
Picture 40 FS703 OPC sample

Silicone mastic, FS703, performed best in this lower temperature test. No adhesion to concrete was lost and therefore air tightness between concrete and melting pipe wasn't lost either. Mastic was intact and felt elastic like before test.

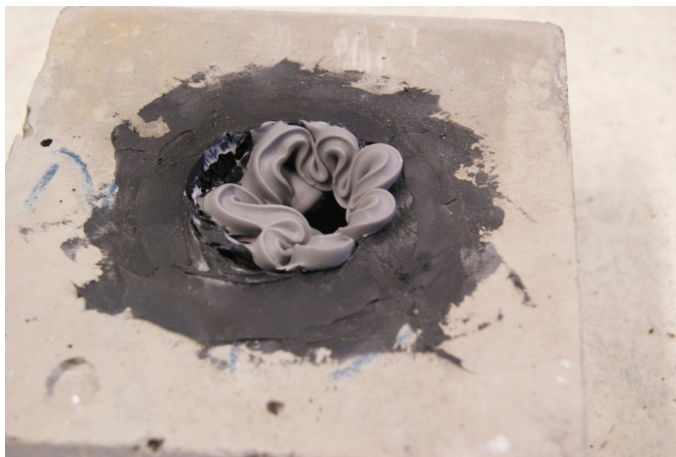
Picture 41 FS703 OPC sample after test at 200°C

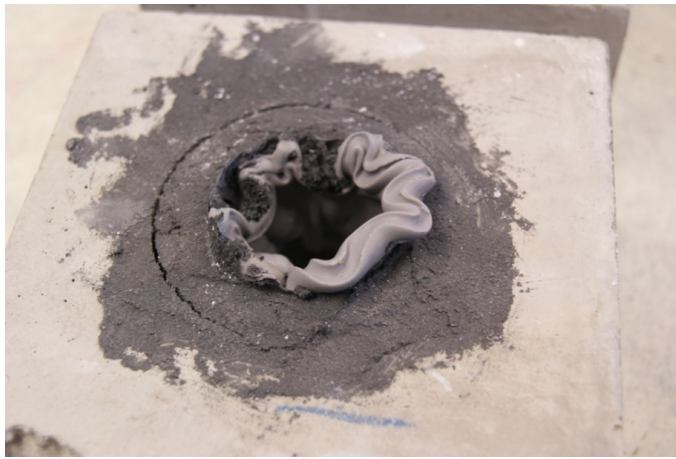
Of course the exposure time to high temperatures in our test exceeds those, which are given for the mastic based on proper fire tests. Test samples were nearly 150 minutes in temperature over 150°C. Judging by this test, intumescent mastic does not perform best in this kind of situation. It performed nearly identical to acrylic FS701.

Picture 43 FS705 OPC sample after test at 200°C

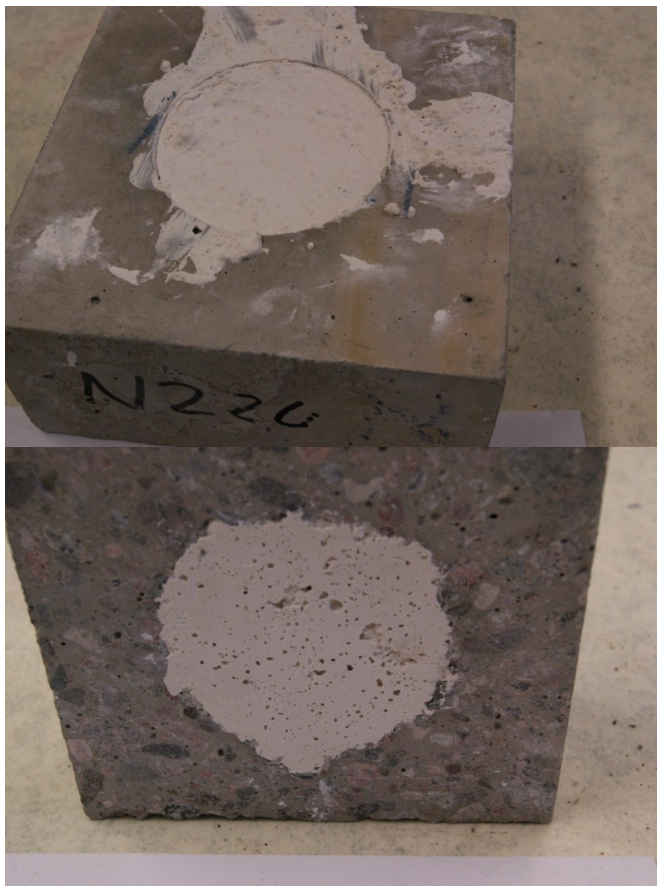
Gypsum mortar, FR220, did not show any signs of damage. If it would have been used similar to other mastics, in a penetration with pipe, the contact surface between concrete and FR220 would have been most likely still intact and secure. Difference would have been witnessed in the contact surface of pipe and gypsum.

Picture 44 FR220 OPC sample after test at 200°C

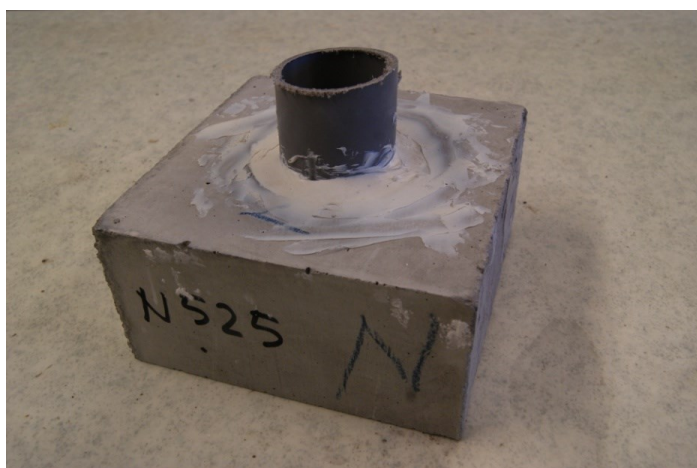
Picture 45 SP525 OPC sample

Normal operating temperature for SP525 is up to 40°C and short term durability temperature is up to 90°C. It has no fireproof properties and it was revealed clearly in heating tests. SP525 was the only one of the mastics in this temperature, which expanded and increased its volume. However the pipe was melted to the bottom of penetration as seen on Picture 46 Also it was the

only one which changed in color, as can be seen in Picture 45 and Picture 46. When removing SP525 and plastic pipe, the mastic was sticky and soft, unlike other mastics after heating.

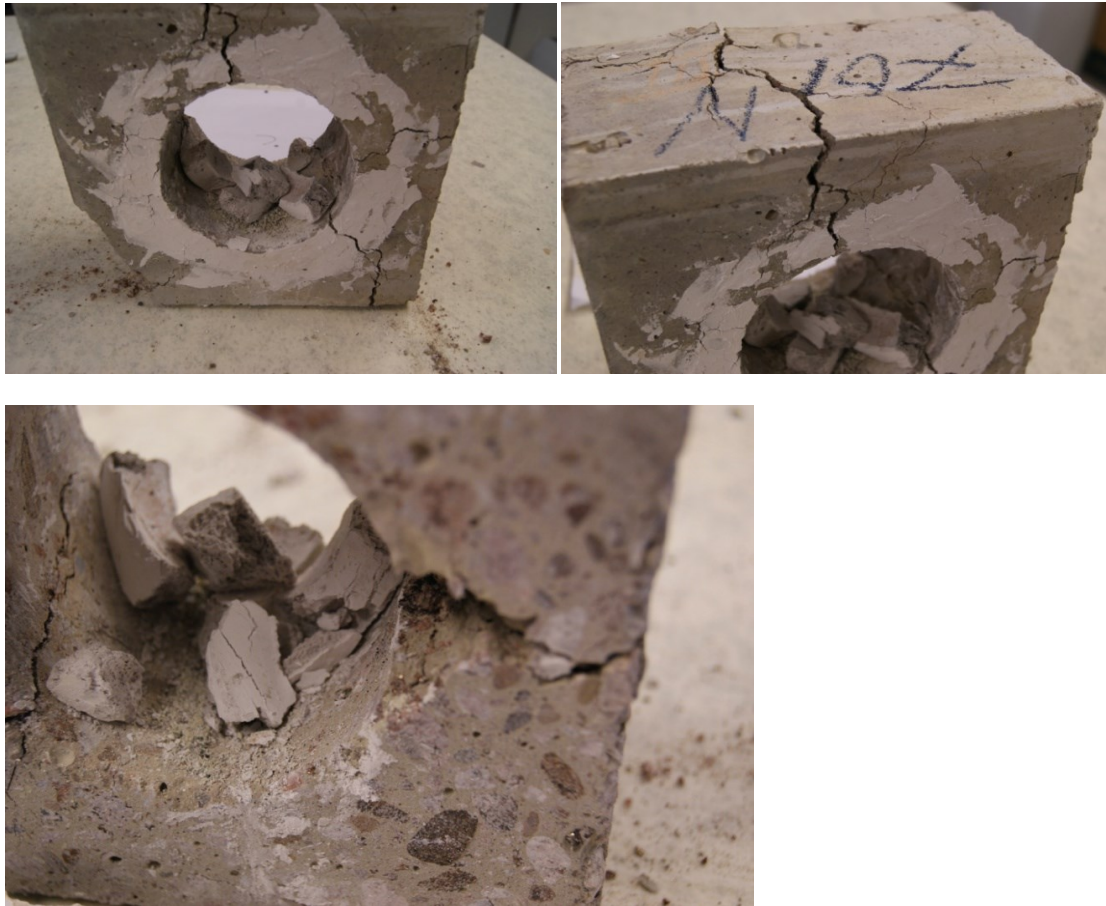
penetration cracks were smaller. Mastic did not seem to have any adhesion to the concrete inside the penetration, but the small layer on the front of sample, was still attached to concrete. This, however, does not serve any function to performance of firestop in this case.

Picture 49 FS701 OPC sample after test at 800°C

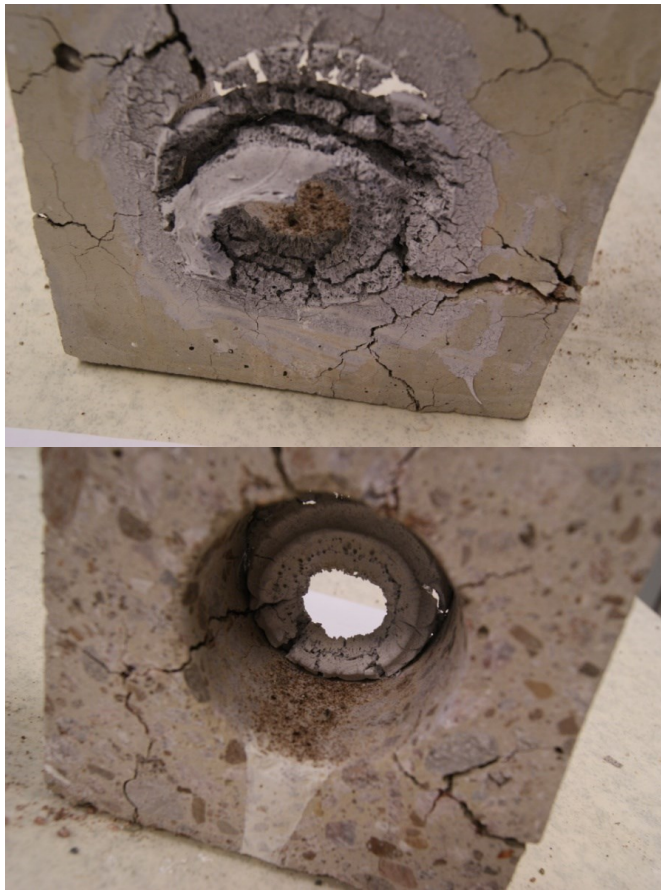
FS703 had lost some of its form and silicone mastic had turned porous both on the surface and inside. Colour had turned from black into grey, and mastic was brittle like in the case of FS701. Cracking was more evenly distributed around the concrete in this sample than in case of FS701. Also there were more cracks.

Picture 50 FS703 OPC sample after test at 800°C

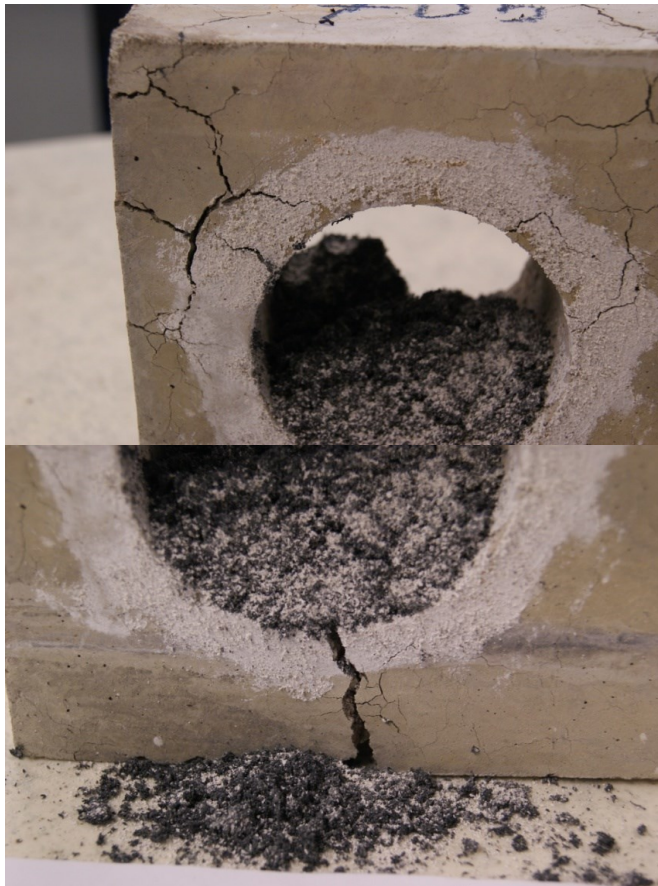
FS705 Intumescent mastic had totally lost its form and firmness. It had turned into char, piling up into two piles on the both sides of the sample in the oven. Amount of char is clearly visible in Picture 58, which was taken after test at 800°C of HPC samples, but same char formations applied also in this case. Concrete was in better condition than in any other sample at 800°C.

Picture 51 FS705 OPC sample after test at 800°C

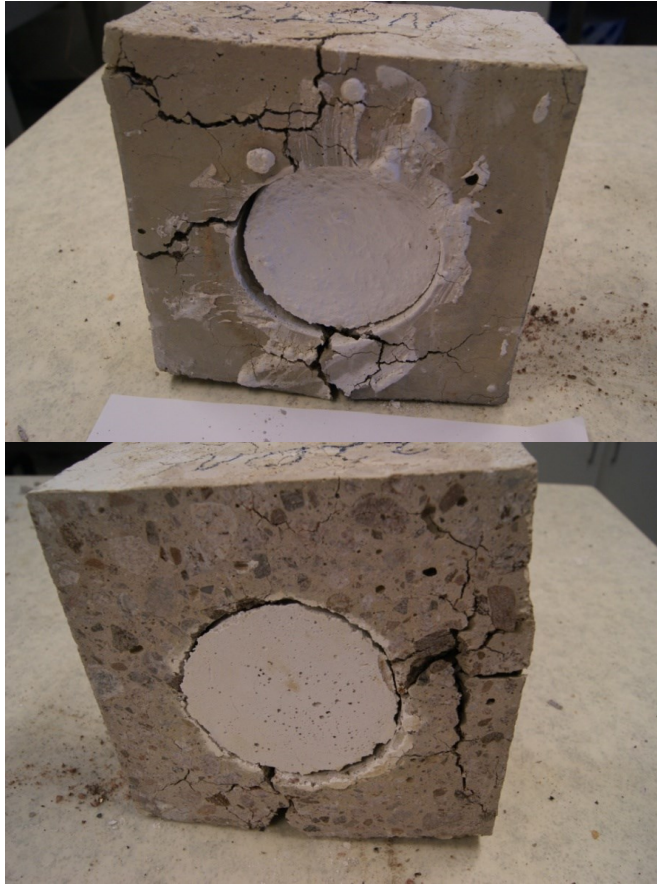
In this case the gypsum piece could be removed from the penetration. Picture 54 shows the cracking formation on the gypsum. This is very minor cracking in comparison with concrete.

Picture 53 FR220 OPC sample after test at 800°C

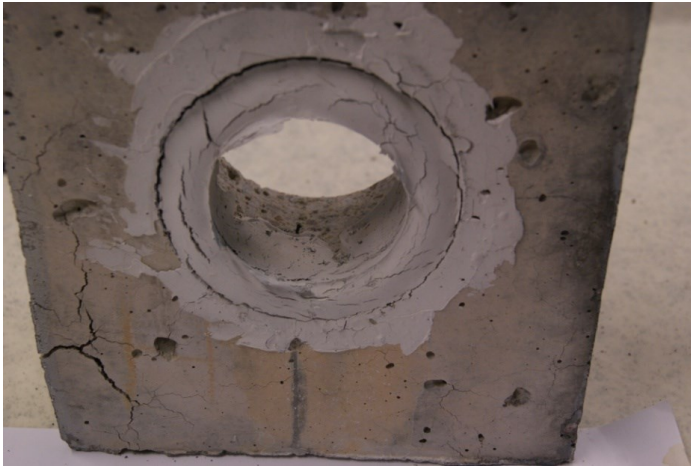
Picture 55 FS701 HPC sample after test at 800°C

FS701 performed very close to the OPC sample. Concrete performed noticeably better than the OPC, which had cracked severely. This time it was possible to take a photograph before the mastic collapsed and crumbled.

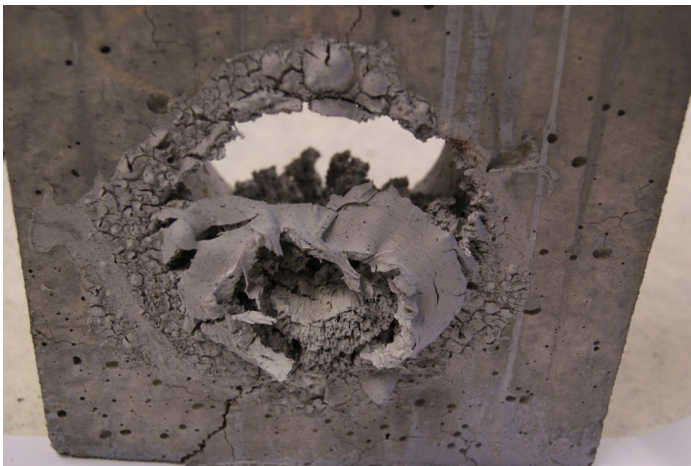
Picture 56 FS703 HPC sample after test at 800°C

In the case of HPC, FS703 had totally collapsed on to the bottom of penetration, barely retaining its form. Concrete had few visible cracks and was colored slightly more grey. Signs of bubble formation on the surface of mastic was visible, as in lower temperature test for HPC sample. Appeared that this could have something to do with the concrete type, because same effect was not visible in the case of OPC samples.

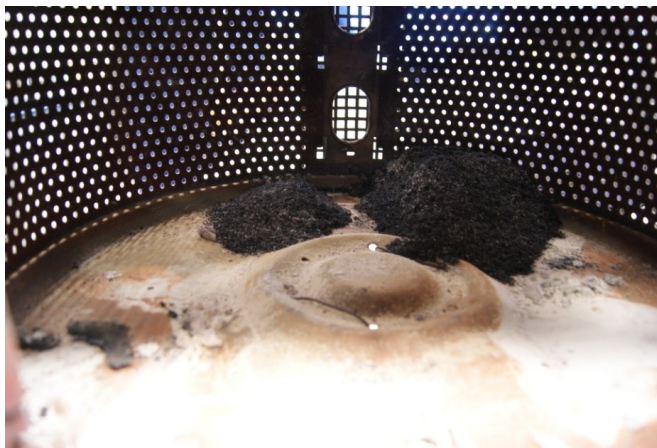
Picture 58 Charring of FS705 HPC sample after test at 800°C

Volume of FS705 had increased extensively, as shown in the charring formation in Picture 58. The char was lightweight and did not have any of the mastics properties prior to the heating.

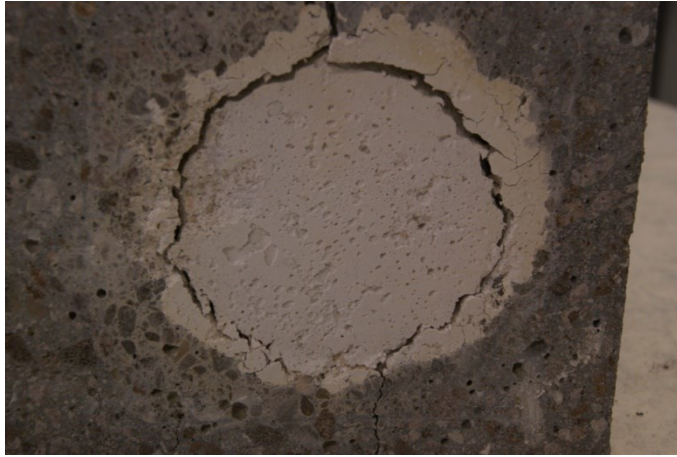
Picture 60 Back side of FR220 HPC sample

HPC sample with FR220 seemed again most damaged comparing to other HPC samples. mastic was intact and again only minor cracking was visible. Concrete was cracked most in comparison with other HPC samples. Picture 59 shows how the whole top part of sample is cracked through. It was clear in this case that if penetration inside concrete was filled entirely with gypsum mortar, it effected negatively on the endurance of the concrete. This was same observation as in the case of OPC samples.

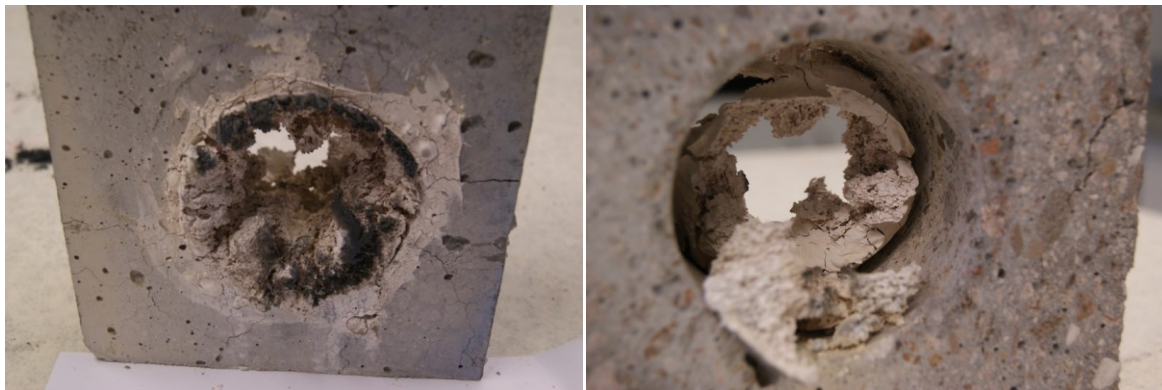
Picture 61 SP525 HPC sample after test at 800°C

SP525 had expanded and still had some adhesion left. This is again different observation compared to all the other cases involving SP525. This indicates that no prediction can be made about behavior of non-fireproofed, in this case M1-classified, sealant mastic at high temperatures.
